# Manhole Inspection Summary

Manhole # S23U\_\_005MH

Insp Date: **1/26/09 7:54 AM**

**Location** Address: **1500 S Monroe st** Cross Street: **Washington BD**

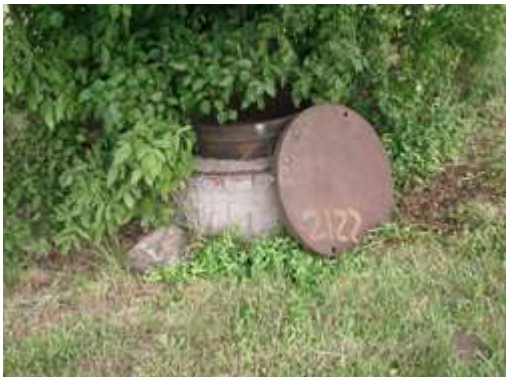
Miscellaneous

MH is above Grade 4ft

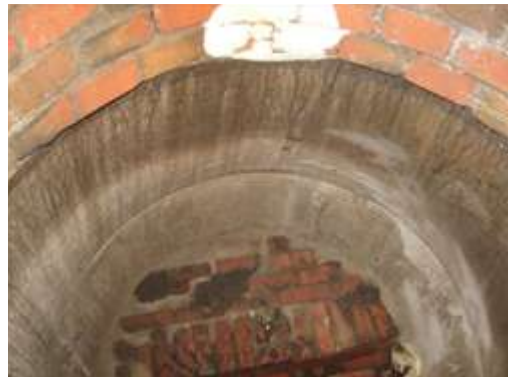
Defect 4

**Corbel** Material: **Brick and Concrete** ☐ Parged Type: **Concentric/Eccentric**  
Condition: ☒ Sound ☐ Cracked ☐ Root Intrusion ☐ Loose Brick ☐ Deteriorated  
Infiltration: ☐ None ☒ **Joint** ☐ Cracks ☐ Mortar ☐ Roots ☐ Wall

signs of infiltration from corbel joint

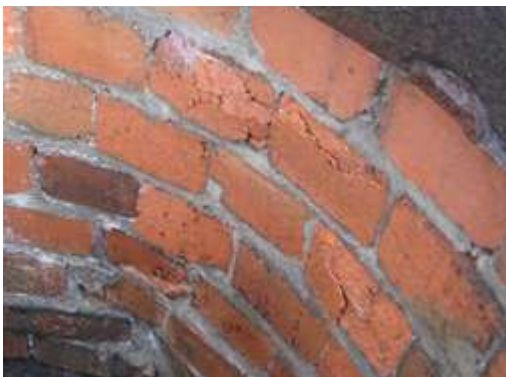
Defect 5

**Chimney / Frame Adjustment** ☒ Exists Material: **Brick** ☐ Parged Height: **30** (in.)  
Condition: ☐ Sound ☐ Cracked ☒ **Root Intrusion** ☐ Loose Brick ☒ **Deteriorated**  
Infiltration: ☒ None ☐ Joint ☐ Cracks ☐ Mortar ☒ **Roots** ☒ **Wall**

deterioration in chimney

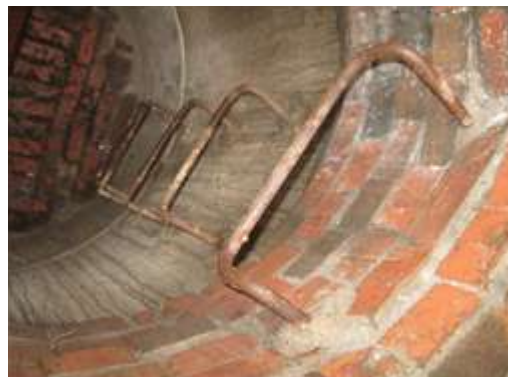
Defect 3

**Steps** Count: **6** Missing: **0** ☒ **Corroded**

corroded rungs

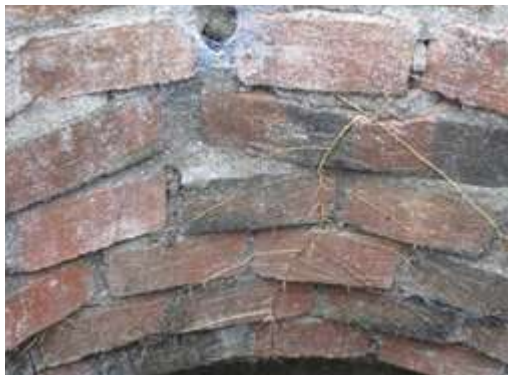
Defect 2

root infiltration chimney wall

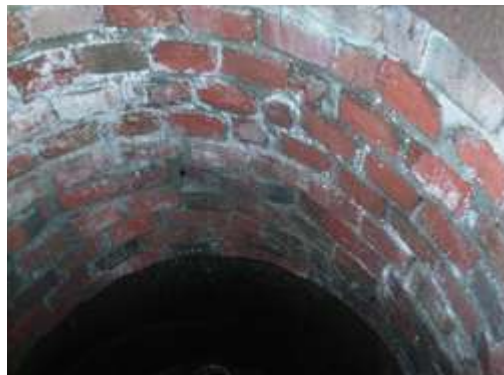
Defect 1

chimney infiltration at roots & wall

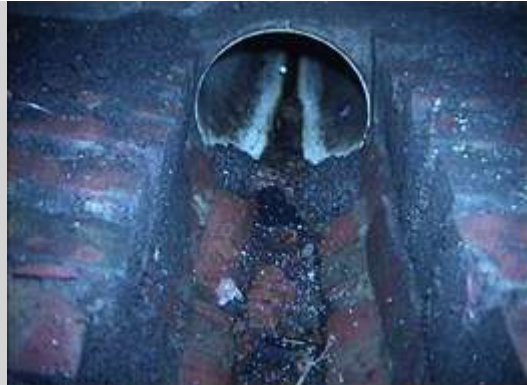
12 O'Clock Outflow

Pipe Height: **8.4** (in.) Rod and Bar (Angled)  
Pipe Material: **PVC** ☐ Pipe Lined  
Invert Depth: **8.80** (ft.) Flow Characteristics: **Slow**  
Deposits: ☒ None ☐ Mud ☐ Sludge ☐ Debris ☐ Grease  
Silt Depth: **0** (in.) Deposits Extent:  
Infiltration: **None** Pipe Seal Cond: **Sound**

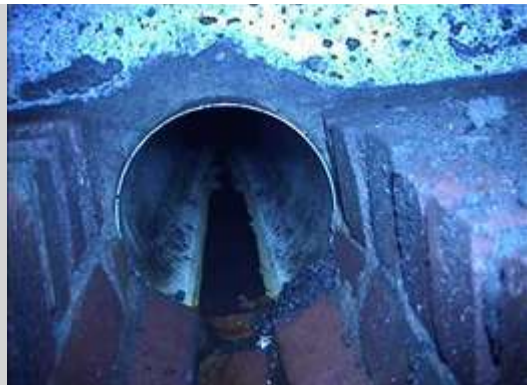
6 O'Clock Inflow

Pipe Height: **8.4** (in.) Rod and Bar (Angled)  
Pipe Material: **PVC** ☐ Pipe Lined  
Invert Depth: **8.70** (ft.) Flow Characteristics: **Slow**  
Deposits: ☒ None ☐ Mud ☐ Sludge ☐ Debris ☐ Grease  
Silt Depth: **0** (in.) Deposits Extent:  
Infiltration: **None** Pipe Seal Cond: **Sound**
